## CLEANROOM ASSEMBLY OF THE LIPAc CRYOMODULE

### Abstract

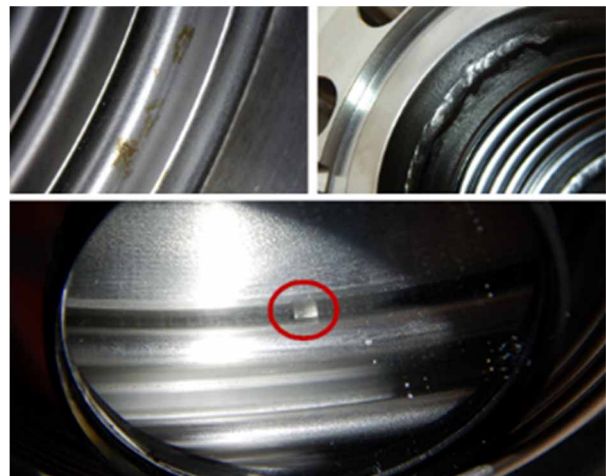
During a first High Pressure Rinsing (HPR) some solenoids presented different aspect defects that can be categorised as follow: rust dots, weld quality issue, material trapped in bellows, external surface finishing, Figure 1.

Figure 1: From top right to bottom, rust dots on bellow, oversized weld seam, trapped material in bellow.

These defects were considered as critical knowing the sensitivity of the SRF cavities with metallic particulate

The less qualitative welds were grinded and polished and then, together with the rusted area treated by pickling and passivation. In addition the solenoids were pressure test again to meet the HPGSL\* requirements. Despite an improvement, black oxidation marks appeared and the procedure was applied a second time. Result can be seen in Figure 2.

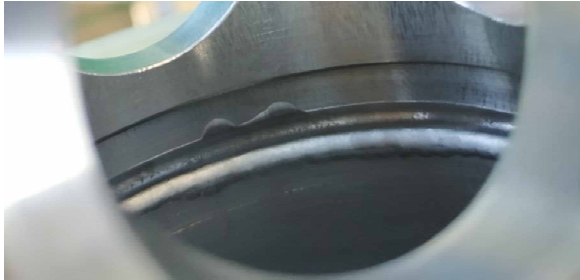
Figure 2: Fully treated weld next to the BPM.

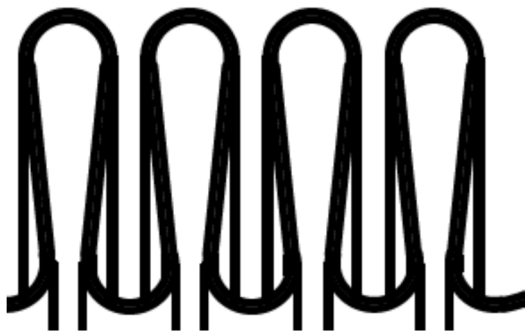
In parallel of the weld treatment, the trapped materials in the bellows were hardly removed due to the Omega shape of the bellows, see Figure 3. Finally, all the solenoid helium vessels were polished to get a smooth finishing compatible cleanroom environment.

Figure 3: Omega shape bellow.

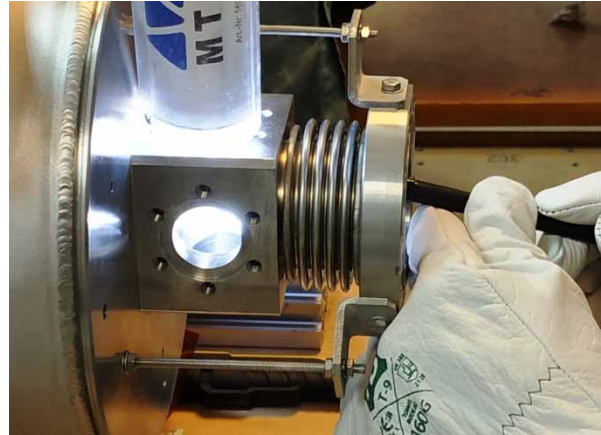
Additional work was needed on the solenoid denominated V06. A chain of events occurred and can be summarised as follow: one BPM threaded hole leaked into the beam vacuum, the hole was recharged by welding without notification by the supplier, a leak was then detected from the bellows seam next to the repaired hole after trapped material removal, the bellow was changed by a new one, Figure 4, the thread started to leak again, the thread was repaired a second time, Figure 5, a small volume was occluded when recharging by welding. Finally the solenoid was leak tight again and could be sent for its cleaning in an ultra-sonic bath before a one hour passivation bath.

Figure 4: Welding of the new bellow on solenoid V06.

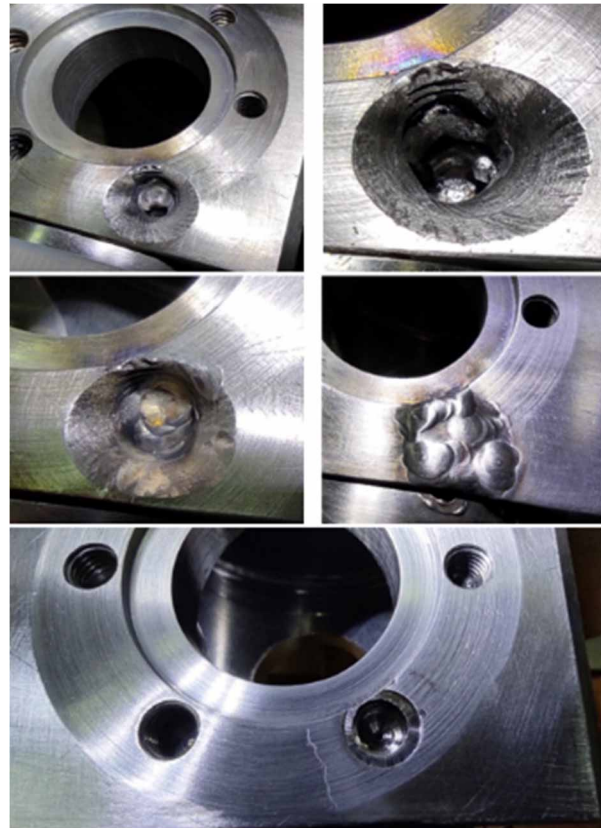
Due to the proximity of the SRF cavity, great care was taken not to increase the magnetic permeability of the steel. The measurements done on the threaded hole before were

already very close to the final value of 1.26 after the second recharge. When moving away from the affected area the value quickly decreases to the acceptable value of 1.02, 1.01. This indicates that the repair done in first place during the manufacturing was carried out without taking care of the magnetic permeability and an excessive heat was applied. Additionally, the helium vessel of solenoid V06 presented a deviation with an excessive value of 1.21. A second solenoid presents also excessive magnetic permeability on its helium vessel with a value of 1.21.

Figure 5: Threaded hole at different stages of charging and its final result (bottom picture).

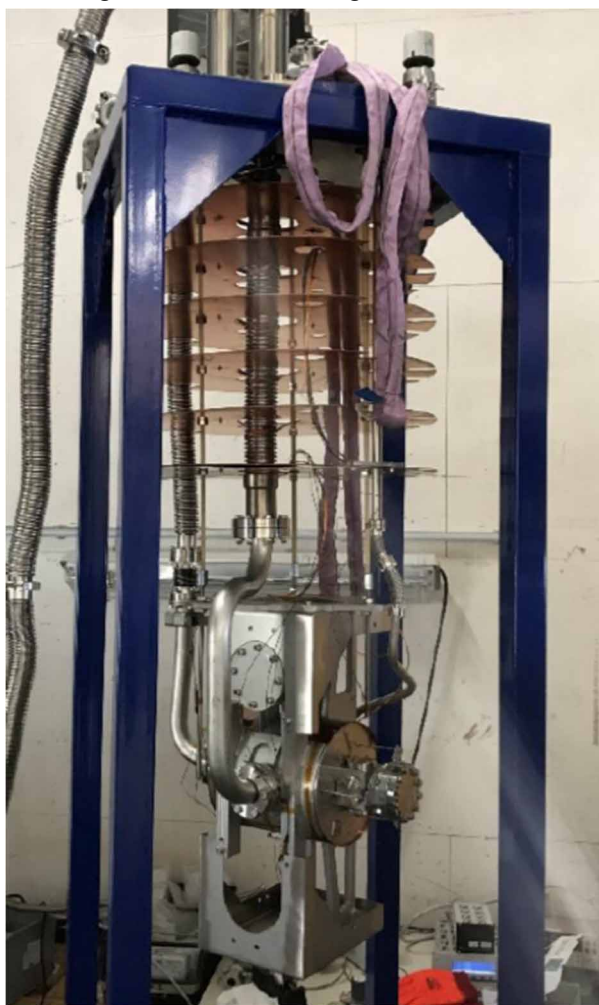
Figure 6: Solenoid installed on the test insert.

The first three tests done on two solenoids were disappointing with strong helium signal in the Dewars each time in the range of 70 K. It was suspected an improper configuration of the current lead interface. Indeed O-ring gaskets were found in place of the Helicoflex mentioned on the configuration document. Once the correct gasket installed and after overcoming issues with strong helium background the tests could resume. However the helium consumption during the test was higher than foreseen, especially to maintain the temperature below the 10 K. It was

therefore decided to release this parameter with 10 min of cooling under 30 K. All solenoids managed to pass the cold leak test successfully.

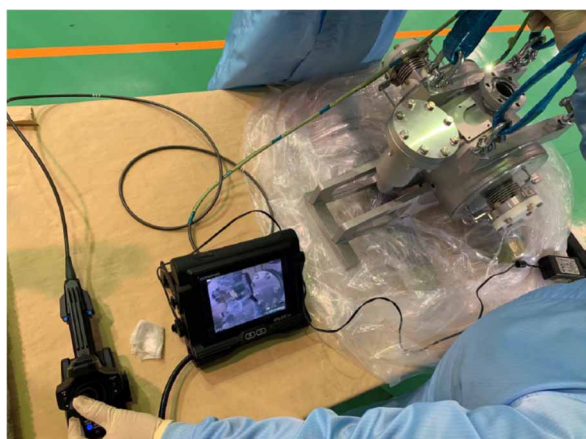
After the completion of the cold leak test in Germany, the solenoids were sent to a supplier in Japan to be prepared for the beam line assembly. The solenoids went for a first cleaning with an Ultra Sonic bath (US bath). Each of them had their helium flanges water tighten to prevent the leaking of alkali solution during the US bath. They were then immersed in water to check the tightness by absence of bubble production before proceeding to the US cleaning. During their handling, two solenoids were reported having rattling noise coming from the helium vessel. Before the High Pressure Rinsing (HPR), the two solenoids were inspected with an endoscopic camera, Figure 7. A screw was found in the first one when opening the helium inlet flange, Figure 8. In the second solenoid, nothing was found and the rattling noise disappeared.

Figure 7: Endoscopic inspection of the helium vessel.

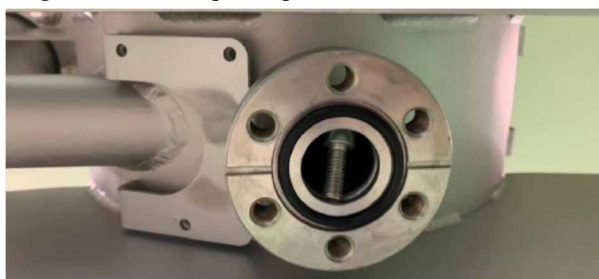
Each solenoids were high pressure rinsed and let dry in cleanroom before the assembly of the PBM pick-ups in cleanroom. In the meantime, the root cause of the rattling noise where analysed. The screw found in the first solenoid appeared to be used during the assembly to keep the outer coil in position. It has therefore no other use, especially for the geometrical positioning of the coil. However, after the HPR the second solenoid presented again a rattling noise.

Figure 8: Screw found in solenoid V06 helium inlet.

In order to prevent further issues during operation, it was decided to send all height solenoids for a tomography after the BPM assembly to check the condition of the different assembly screws and centring pins.

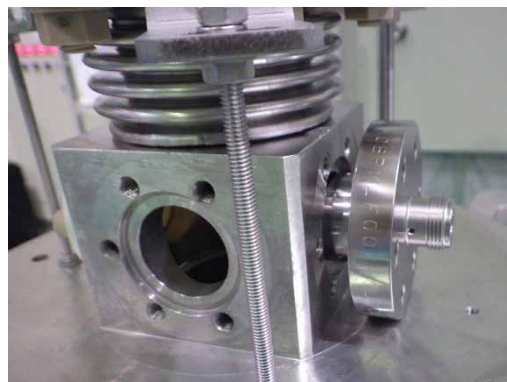
The BPM pick-ups assembly proceed smoothly, except for one of the 32 sensors. Indeed, for the repaired solenoid, V06, it was impossible to insert the pick-up on the BPM side that had one thread repaired by welding, Figure 9. It was quickly suspected that the different repairs led to some stress released in the BPM, where the tolerances are extremely tight. The measurements of the faulty BPM socket confirmed the deformation on one of its side. It was therefore decided to proceed to a light polishing of the pick-up head by 50  $\mu\text{m}$  and to proceed to its assembly once the solenoids back on Rokkasho site. The polishing of the pick-up head did help a lot, but small gap subsisted to get it closed entirely. Finally the head was adjusted on a lathe machine by removing an additional 150  $\mu\text{m}$  on the head diameter. This last step allowed a complete insertion of the pick-up in the BPM. However, after many attempt it was impossible to get leak tight within the specifications. This last aspect will be described in a later part dedicated to leak issues.

Figure 9: Solenoid V06 faulty BPM pick-up.

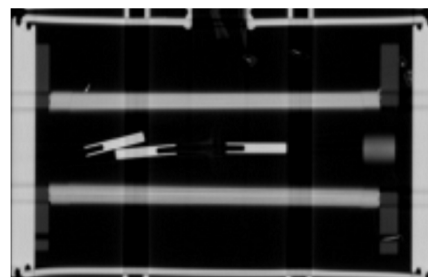
**Tomography results** The scanner revealed that for some solenoids, some of the pins free before assembly were push out partially or totally. Thus, for the second solenoid presenting a rattling noise, it was found that three centring pins of the inner coil were totally removed and are now sitting in the space between the two coils, Figure 11. These three pins are now enclosed and cannot be removed.

Based on the result of the scanner, two solenoids were considered as sensitive for the good operation of the SRF Linac. Rather than delay the assembly for several years by manufacturing new solenoids, it was decided to find the best positioning for each of them to be able to operate in a degraded mod if any limitation occurs during operation. This work is described in [4] of the present conference.

Figure 11: Centring pins laying on the outer coil.

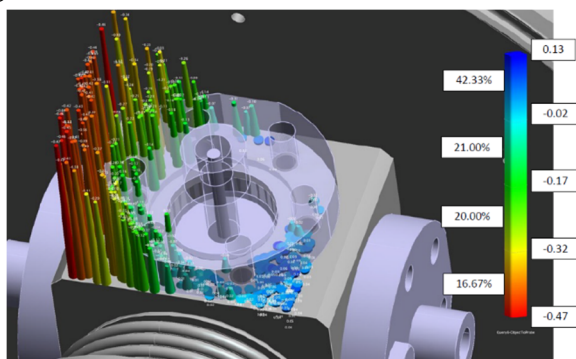
**The solenoid V06** had its last BPM pick-up leaking. Two attempts of repolishing the seal groove in cleanroom to preserve the HPR failed. A first 3D analysis, Figure 12, showed a deformation of the body surface of the BPM, having the reference surface tilted with respect to the seal groove.

Figure 12: Parallelism between BPM body and sealing groove.

The reason of the leak was found in two scratches that were removed by an appropriate third polishing. A diamond shape gasket was then used in place of the Helicoflex whose sealing groove requirements were not fulfilled anymore. Solenoid V06 is now ready for a new HPR prior to come back in cleanroom.

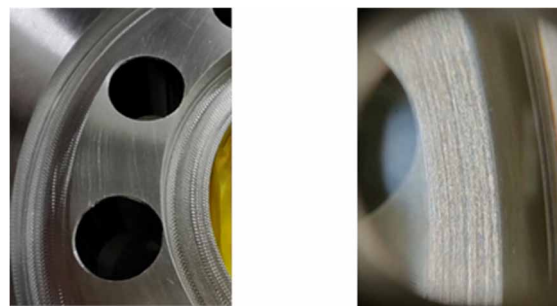
**The two Cold Warm Transitions (CWT)** used to transfer the beam to and from the cryomodule presented inappropriate sealing surface finishing, Figure 13, required for the double Helicoflex gasket interface. A first polishing attempt did improve a bit the situation by getting one of the gasket leak tight. A second attempt failed and did not succeed to have both gaskets leak tight at the same time. Another attempt is currently ongoing. New gasket designs are also being procured as alternative solution.

Figure 13: CWT before (left) and after (right) polishing.

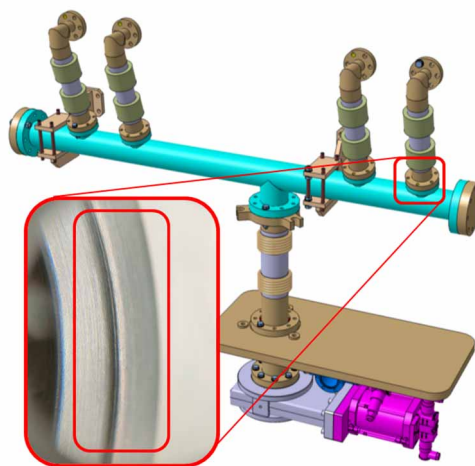
Figure 14: Rounded edge knife from the pumping manifold (in blue).

**The pumping manifold** used to pump the beam line from the two middle cavities is the last component failing to be leak tight at inspection. Four of the seven CF interfaces leak. A close inspection revealed that most of the knife edges of the CF flanges are actually rounded, Figure 14. It is suspected an issue during the passivation of the manifold with an improper protection of the different flanges. Regarding the number of flanges damaged and the heavy processing to change them, it is decided to procure a new manifold.
