VISUAL, OPTICAL AND REPLICA INSPECTIONS: SURFACE PREPARATION OF 650 MHz NB CAVITY FOR PIP-II LINAC*

V. Chouhan[†], D. Bice, D. Burk, M. K. Ng, G. Wu
Fermi National Accelerator Laboratory, Batavia, IL, USA

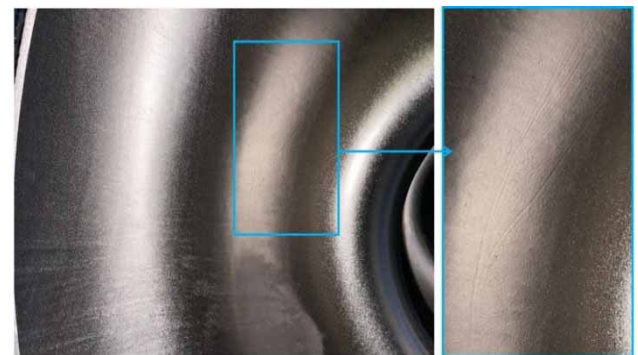
Figure 2: A part of the half-cell of an as-received HB650 cavity: Photograph captured with a digital camera inserted manually inside the cavity (left). Zoom-in image showing minor scratches (right).

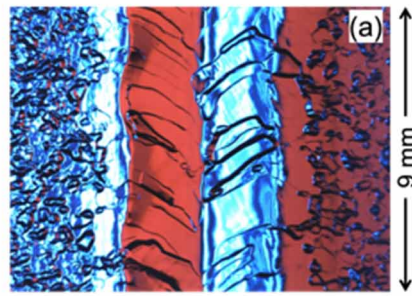
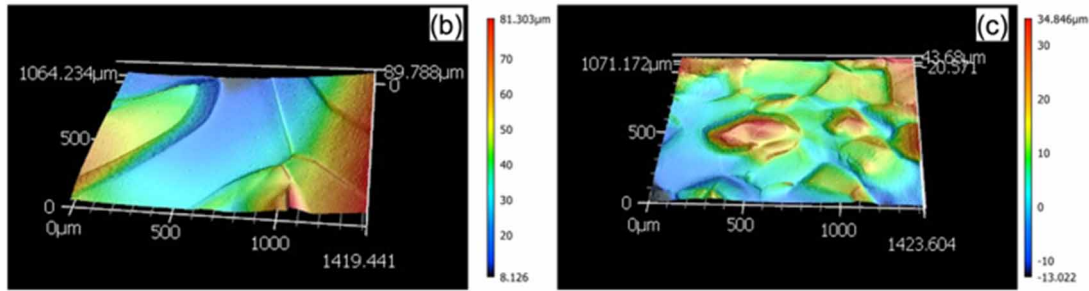
Figure 3: Optical image of the equator surface (a). LCSM images of replica surface representing the weld (b) and near-weld (c) equator positions.

To examine the surface, the entire equator surface in all 5-cells was scanned with the optical camera. A typical image of the equator surface is shown in Fig. 3. The optical inspection revealed a rough surface that differed from a standard electropolished surface. Although the optical images clearly showed that the surface was rough, it could not provide any information on roughness value. To obtain this information, a replica of the equator surface was created and examined using a laser confocal scanning microscope

(LCSM). The replica images for weld and near-weld zones on equator are presented in Fig. 3 (b) and (c). Average roughness R_a of near-weld surface was estimated to be ~8 μm and grain step height was measured to be ~32 μm . The roughness was significantly higher than the buffered chemical polishing (BCP) surface which is usually found very rough with grain step height of ~5 μm . The rough surface might be responsible for the low quench field.

The information obtained with optical and replica images played a crucial role in evaluating the EP performance. It became evident that modifications to the electropolishing conditions were necessary to achieve a smoother surface. A study was conducted to optimize the EP parameters, details of which can be found elsewhere [4, 5]. The cavity after reset EP under optimized conditions met the E_{acc} specification ($E_{acc} = 22.4 \text{ MV/m}$) set for the baseline test as reported elsewhere [5, 6].

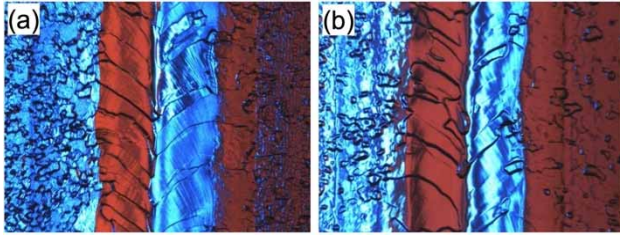
Throughout the process of parameter optimization, optical inspections were performed at various stages to evaluate the surface yielded with different EP conditions. Figure 4 shows two images of the equator region, one after 70 μm removal under unoptimized conditions, and after 120 μm removal that included last 27 μm removal using the improved EP conditions. These images clearly demonstrate that the optimized EP process led to a smoother surface.

Figure 4: Optical image after unoptimized EP performed for 70 μm removal (b) Image after additional 23 μm removal with unoptimized EP and 27 μm removal with improved EP. Image size: 12 \times 9 mm.

Based on this feedback, two new cavities (B61C-EZ-101 and -104) were processed using the optimized EP conditions, taking into account the surface smoothing observed in the images.

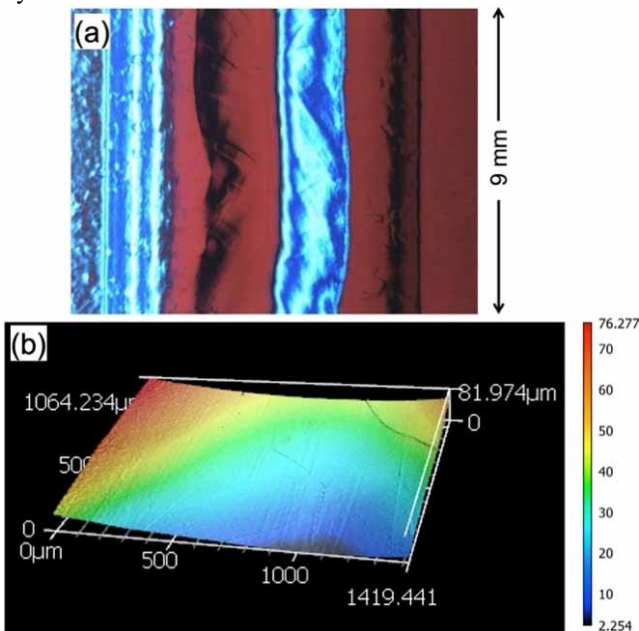
B61C-EZ-101 and -104: These cavities experienced optimum EP conditions in bulk and light EP [4, 5]. The cavity surface was examined with optical camera and by making replica. The replica that provided high-resolution features at the sub-micron level was inspected with LCSM. The optical and replica surface images after 120 μm removal are shown in Fig. 5. Average roughness R_a measured using LCSM was $\sim 0.6 \mu\text{m}$. The effectiveness of the optimized EP conditions was confirmed through these optical and replica inspections.

Both cavities after bulk removal of 120 μm were underwent a heat treatment at 800 $^\circ\text{C}$ and 40 μm light EP [4]. The cavity B61C-EZ-104 qualified in the baseline vertical test [5, 6]. Despite applying the optimized EP conditions, cavity B61C-EZ-101 quenched at 20 MV/m, failing to meet the specified baseline performance requirement in vertical tests. This early quenching may have been caused by a surface defect.

Figure 5: Optical image of typical equator surface of B61C-EZ-104 (a) and LCSM image of the replica representing the equator surface of B61C-EZ-101.

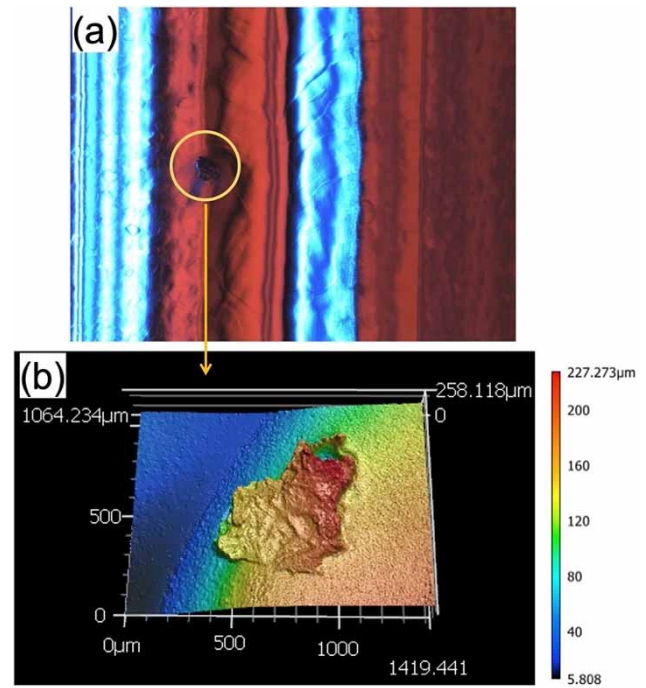
The entire equator surface in all five cells was inspected with the optical camera. A unique feature on the equator surface in cell-1 was found as shown in Fig. 6 (a). The feature found in the optical inspection was unclear to decide the next surface processing.

Figure 6: (a) Optical image showing a unique feature (image size is 12 \times 9 mm). (b) LCSM image of replica representing the surface in (a).

To get a detailed information of the feature, replica of the surface was made. An LCSM image of the feature captured by replica is shown in Fig. 6 (b). The image represented that the feature on the cavity surface was a random-shaped crater with a depth of $\sim 170 \mu\text{m}$. The deep crater with sharp edges was identified as the likely cause of the early quenching.

Given the size and depth of the feature, employing additional electropolishing (EP) was deemed unsuitable for removing the surface defect. Therefore, the decision was made to do local mechanical grinding to remove the defect. The subsequent sections will provide further details on the specific approach taken for grinding.

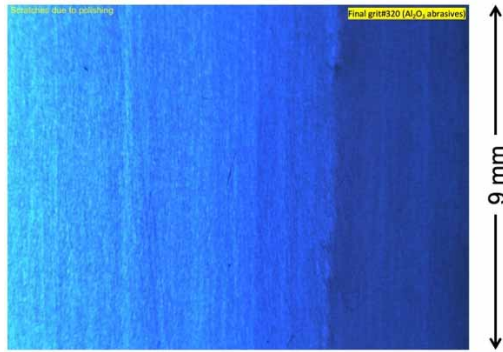
The defect spot in the end cell of cavity B61C-EZ-101 was manually polished with aluminum oxide (Al_2O_3) abrasive media while the cavity was sitting on the optical stand for surface inspection during the different polishing steps performed with different grit size papers. The polishing paper was fixed on a handy tool having a rubber pad. This rubber pad holding the polishing paper might minimize embedding of particles into the Nb surface. The final polishing step utilized a grit size of 320. An optical image of the polished surface to compare with the original image (Fig. 6) is shown in Fig. 7. The image revealed that the defect was successfully polished, resulting in a smooth surface with

traces of abrasive particles. Optical inspections conducted at various stages of the polishing process served as guidance to determine when to stop the polishing procedure.

Figure 7: Optical image of the defect position shown in Fig. 6 after local grinding with Al_2O_3 abrasive media.

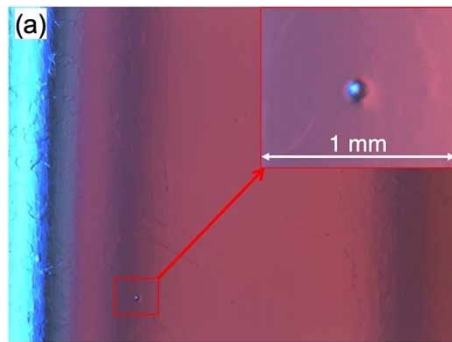
Figure 8: (a) Optical image of equator surface mechanically polished followed by EP for $60\ \mu\text{m}$ removal. (b) Optical image of replica representing surface in (a). (c) 3D image of the negative replica showing the pit.

The next processing step was chosen to be electropolishing for a removal thickness of $90\ \mu\text{m}$. This removal depth was considered sufficient to remove embedded particles out from the Nb surface. Following the EP process, an optical inspection was conducted to assess the presence of any remaining defects on the surface. The inspection revealed the presence of certain polishing features, including pit- or bead-like structures in the polishing region, as shown in Fig. 8 (a).

Given that optical inspection alone could not definitively determine whether these features were pits or embedded particles, a surface replica was made to confirm the same. The replica image apparently showed that the cavity surface had a pit having a diameter of $\sim 200\ \mu\text{m}$ and a depth of $\sim 7\ \mu\text{m}$. It is likely that this pit formed when a large-sized embedded particle detached from the surface during the EP process. The results suggested that the polishing media and the grit size should be properly selected to avoid such pit

formation on the surface. Based on the depth of the observed pits, $20\ \mu\text{m}$ removal in EP was decided, where each $10\ \mu\text{m}$ was removed before and after subjecting the cavity to a heat treatment at $900\ ^\circ\text{C}$ for 3 hours.

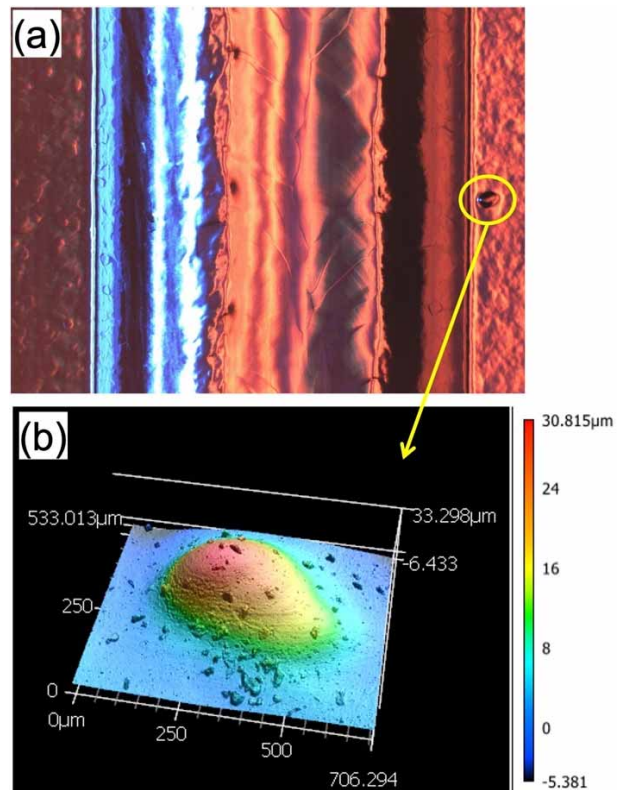
B92F-RI-203: Optical inspection of the cavity surface was performed after $160\ \mu\text{m}$ removal in EP conducted with the conditions specified in reference [7]. A defect appeared as a cat-eye feature on equator surface in cell-1 of the cavity. The cat-eye feature is usually treated by local mechanical grinding or centrifugal barrel polishing. To obtain detail of the cat-eye feature, replica of the surface was prepared. The optical image of the surface and the corresponding replica image are shown in Fig. 9 (a) and (b). The feature was a wide pit with depth of $\sim 25\ \mu\text{m}$, respectively. This pit indicated the presence of an underlying defect in the Nb bulk, which became apparent as a pit following the $160\ \mu\text{m}$ removal during the EP process.

Figure 9: (a) Optical image showing a cat-eye feature on equator surface in cell-1 of B92F-RI-203. (b) 3D image of the cat-eye feature captured with surface replica.

Since the cat-eye feature had no sharp edges, the surface was not mechanically polished. The cavity was processed with $900\ ^\circ\text{C}$ followed by EP for $10\ \mu\text{m}$ removal.

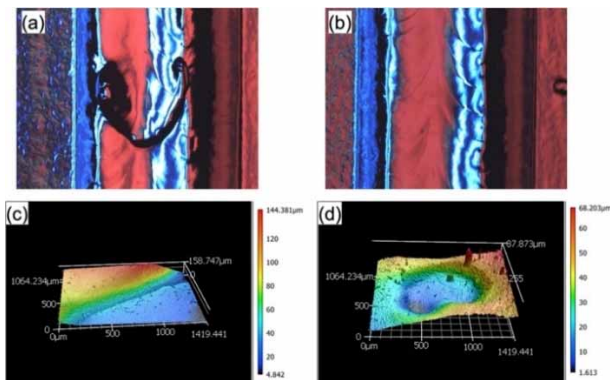
Figure 10: Optical images (12×9 mm) (a) showing defect on weld-zone and (b) a defect near weld-zone of equator. (c) Replica image of the defect in (a). (d) Replica image of the defect in (b).

B92F-RI-202: The equator surface, as observed with optical camera, of the as-received cavity showed some weld features on the equator in all the five cells. An optical inspection performed after 167 μm removal in the EP process showed that the features remained on the surface as shown in Fig. 10 (a). An additional defect on the equator surface in cell-5 was found (Fig. 10 (b)). The replica of both features was produced. The LCSM images of the replica surface is shown in Fig. 10 (c) and (d).

The replica image revealed that the edges of the feature were not sharp. Considering the feature details in the replica, the cavity surface was processed to prepare for a baseline test. The vertical test result will be reported later.

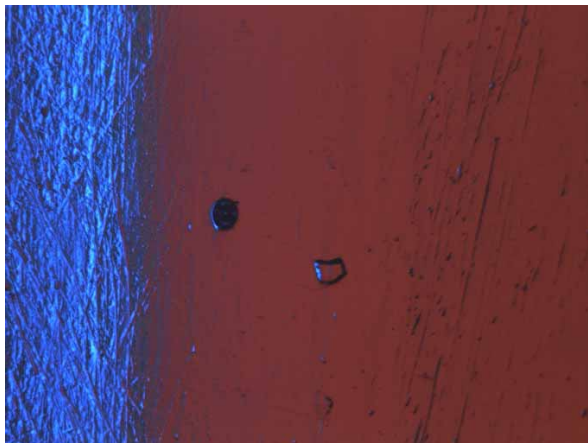
B92D-RRCAT-502: The cavity was processed with EP for 150 μm removal, N-doping, and post-doping EP for 5 μm removal. The cavity tested after the processing was prematurely quenched at 11.2 MV/m. In optical inspection, the cavity surface in cell-5 showed a pit that was polished by local grinding followed by 60 μm EP, heat treatment at 800 °C for 3 h and light EP for 10 μm. The pit was still present on the surface as found in an optical inspection (Fig. 11).

Figure 11: Defect on the equator surface in cell-5 of B92D-RRCAT-502. Image size: 12×9 mm.

Replica was made to get the pit feature. The diameter and depth of the pit were ~450 μm and 160 μm, respectively. Similar to the grinding process applied to B61C-EZ-

101, local grinding on the defect position was performed with Al₂O₃ abrasive media having grit size of 80–400 until the defect disappeared from the surface. Following the grinding, EP for 60 μm was applied to the cavity. The cavity reached at 29.8 MV/m and met the baseline specification.
