# NIBIUM CHRONICLES: SURFACE QUALITY INVESTIGATION AND RECOVERY DURING MATERIAL PROCUREMENT FOR THE PIP-II HIGH BETA 650 MHz CAVITIES

A. Shabalina<sup>†</sup>, ASTeC, STFC, Daresbury Laboratory, Warrington, UK

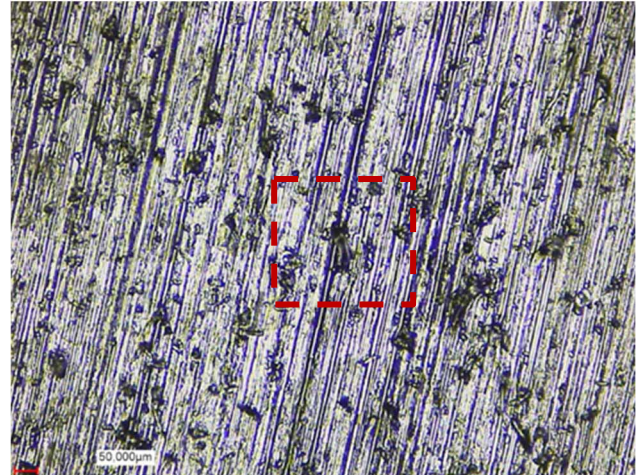
The problem manifested as a very high level of noise observed during scanning, indicating an enormous number of irregularities on the surface. The defects appeared as pits, uniformly distributed on both sides of the disks, Fig. 1 most with dimensions ranging from 10 to 40  $\mu\text{m}$  in depth and 40

to 70  $\mu\text{m}$  in width, Fig. 2, and some reaching the depth of 70  $\mu\text{m}$ .

Figure 1: Half-cell material for PIP-II HB650 MHz cavities as received.

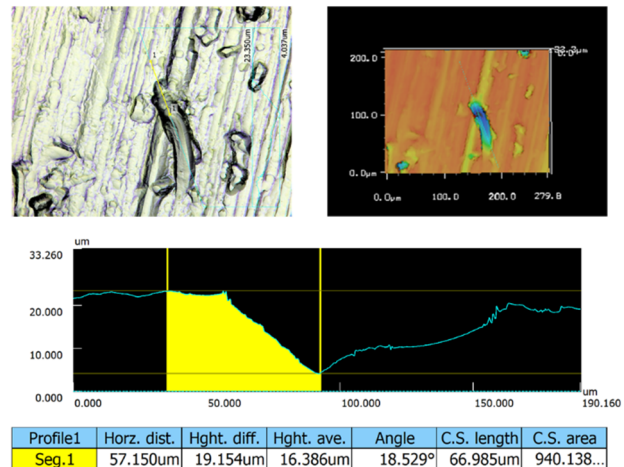
Figure 2: 3D profile of one of the pits shown in Fig. 1.

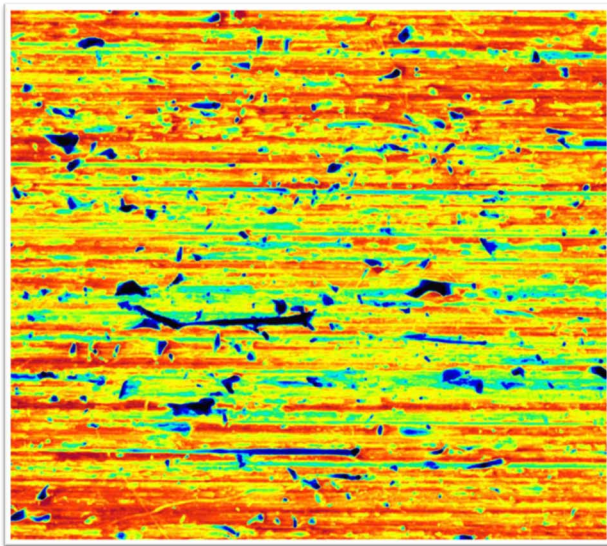
By November 2021, at least 500 sheets from various customers had been checked at DESY for surface defects. The results were very concerning - all orders placed with this supplier since May 2021 were affected. Sampling non-cell material at Daresbury supported the findings Fig. 3.

Figure 3: Beam tube material for PIP-II HB650 MHz cavities.

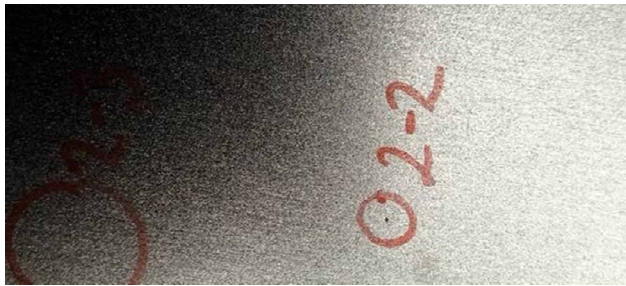
The defects were not visible by a naked eye, the surface just appeared subjectively rougher, but when compared side-by-side with a known good material, the grinding grooves looked noticeably deeper, Fig. 4.

Figure 4: Surface of one of the PIP-II disks appears normal without magnification.

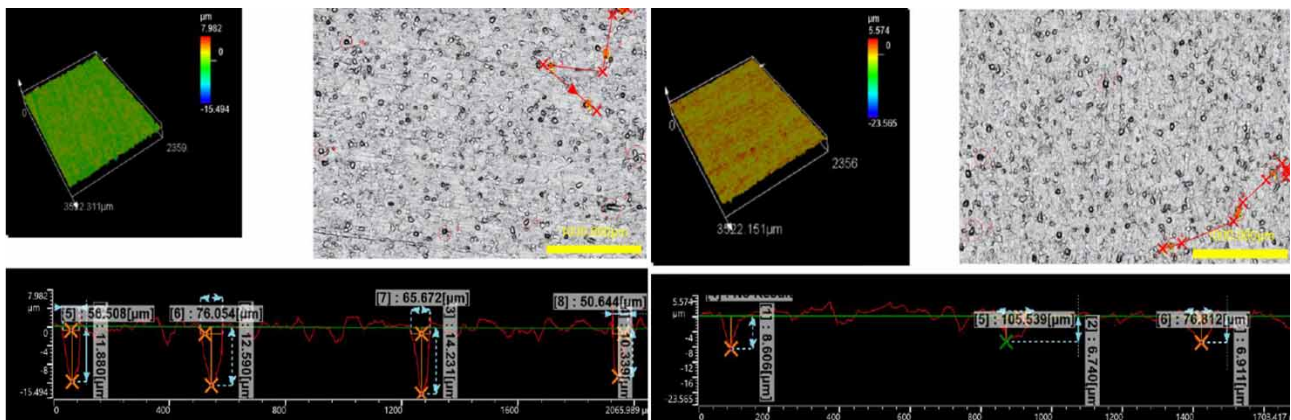
Several etching procedures were evaluated via 3D microscopy by the manufacturer, Fig. 6. The results were unsatisfactory for PIP-II – many pits were still present and would generate a similar level of noise during ECS. The samples were sent to DESY despite recommendations against it, and subsequently failed the inspection in December 2021. Recovery efforts for other projects were ongoing and included surface treatment tests conducted by the cavity manufacturers as well.

Figure 6: Surface quality after two different etching trials.

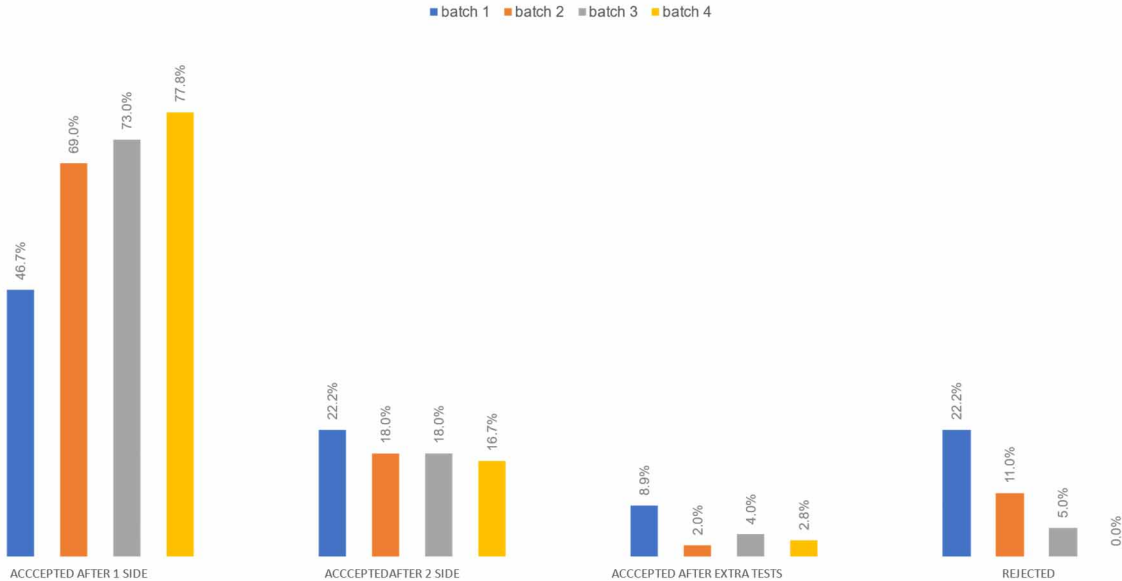
### PIP -II NB SHEET INSPECTION STATS

Figure 7: Nb disk batch incoming inspection performance.

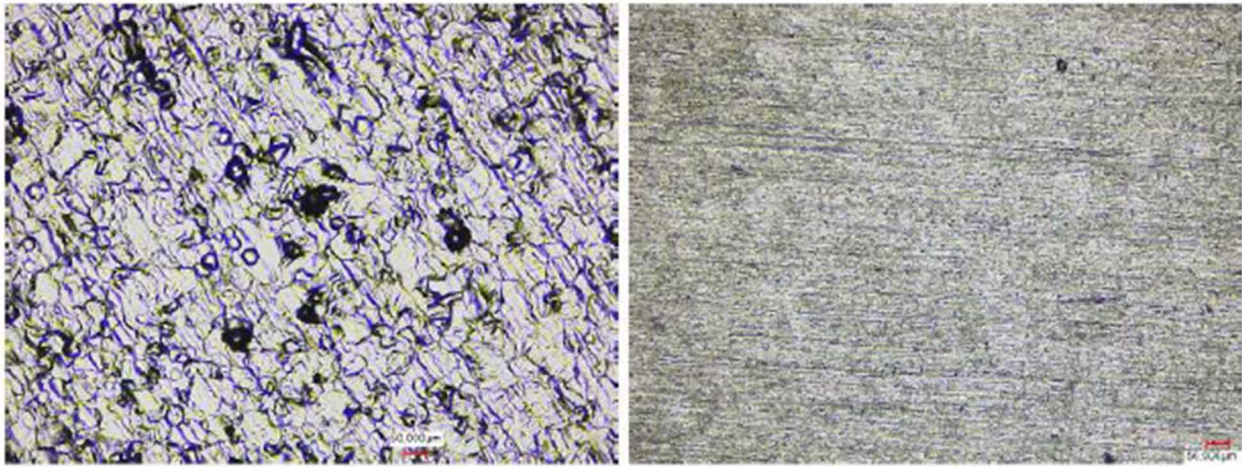
The resulting surface quality gradually increased with each delivery, Fig. 8, meeting and exceeding a previously set benchmark in the final batch, Fig. 8.

Figure 8: Surface quality after the first rework attempt (left), and the final results (right).

Recent changes to the surface treatment were reverted, and an extra-fine polishing and etching steps were added to the final production recipe. Multiple rework recipes were applied, depending on the condition of each disk after the unsuccessful grinding and/or etching trials. However, the acceptance criteria remained the same.
