# Cleanroom assembly of the LIPAc cryomodule

## Superconducting Solenoids Reparation

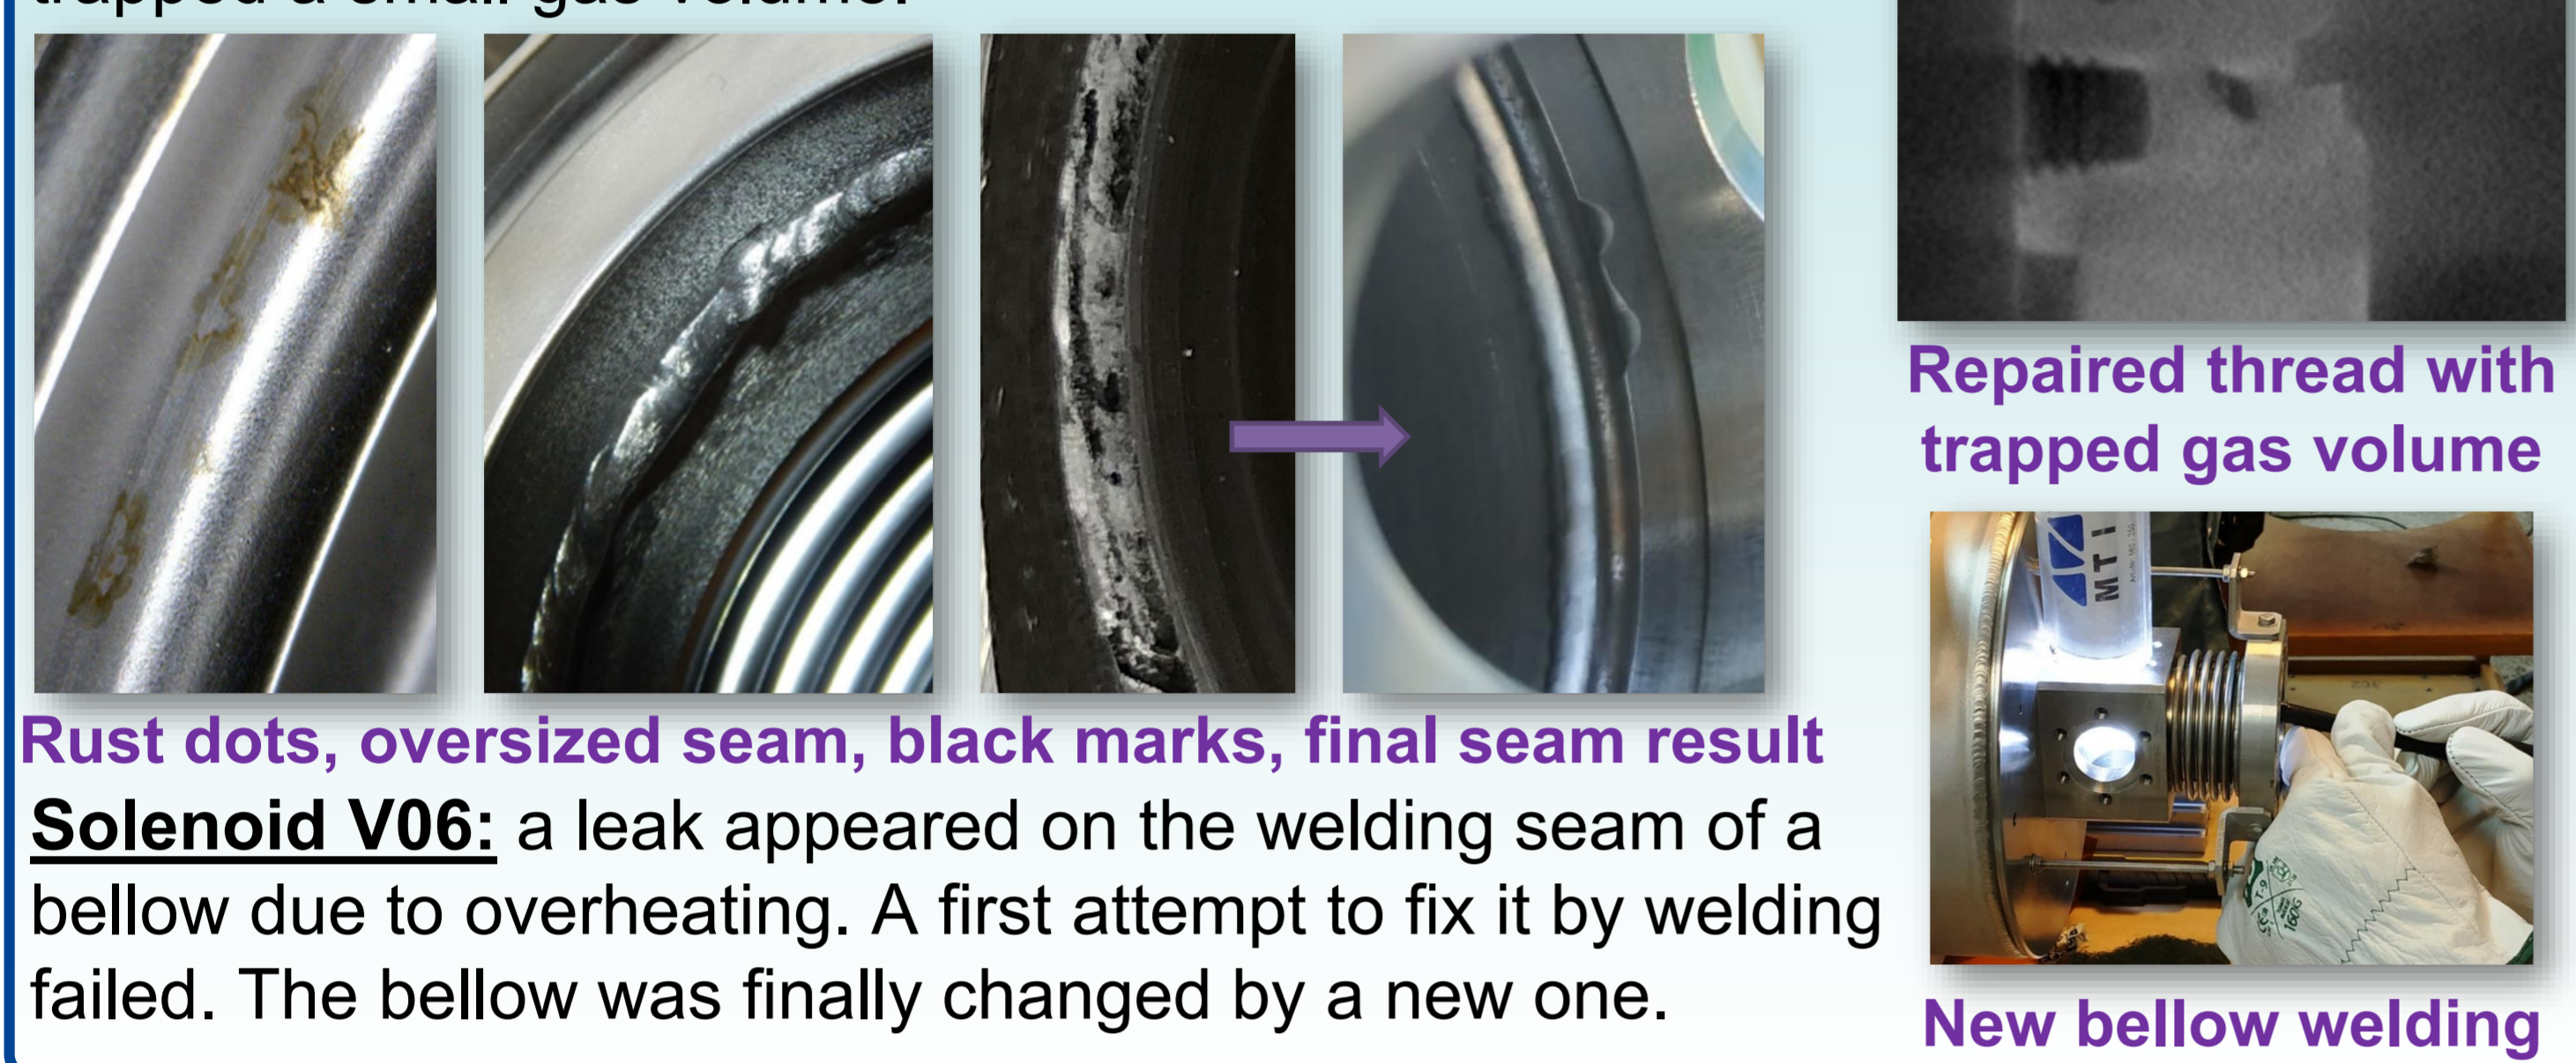
Different defaults needed to be fixed: rust dots in bellows, oversized seams, surface finish of the welds, one BPM thread leaking in beam tube.

**Corrective actions in Spain:** grinding followed by pickling and passivation. **BUT** new black marks appeared requiring a new iteration. Leaking thread was recharged with welding material but trapped a small gas volume.

**Rust dots, oversized seam, black marks, final seam result Solenoid V06:** a leak appeared on the welding seam of a bellow due to overheating. A first attempt to fix it by welding failed. The bellow was finally changed by a new one.

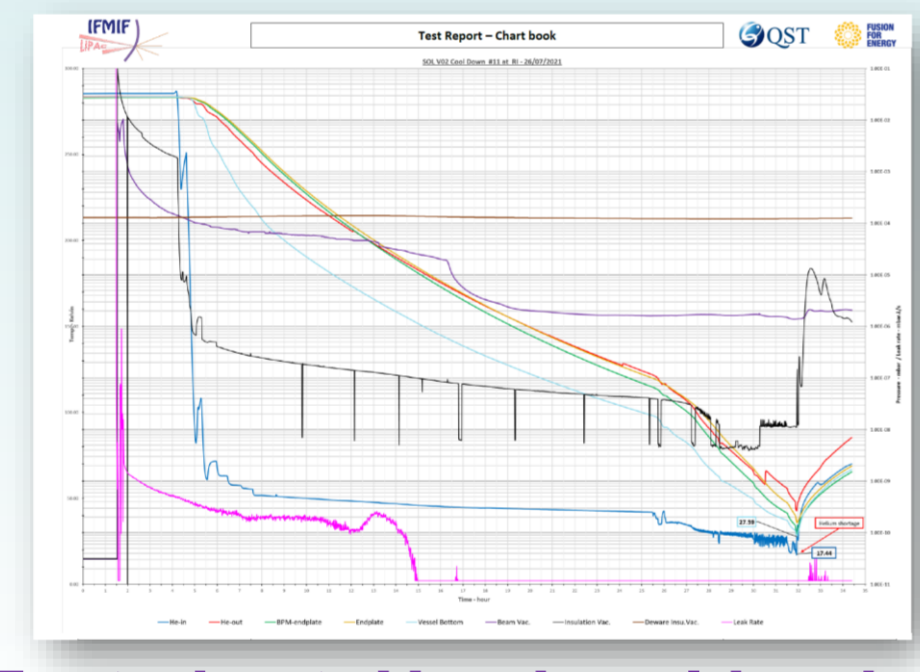
- Small test stand fed with Helium dewar.
- Leak detector suffer from helium contamination.
- Relocation of the leak detector to another room improved the test results.
- 2 solenoids presented leaks approaching the 70 k area => wrong configuration discovered on the current lead interface (O-ring instead of Helicoflex);

Test chart, He signal in pink

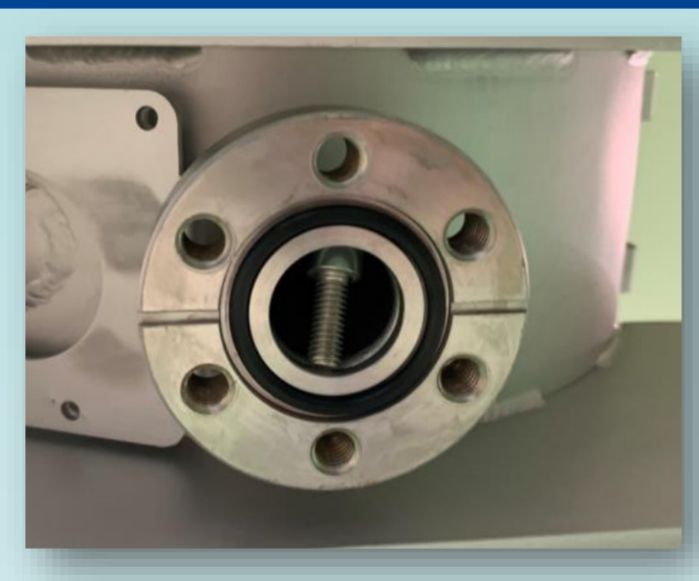
- Solenoid preparation in **Japan** for the cleanroom assembly.
- Ultra Sonic bath followed by High Pressure Rinsing, before BPM pick-up assembly in cleanroom.
- During HPR, a screw was found in a helium vessel.
- A second solenoid presented a rattling sound.
- After an endoscopy the solenoids went all for a tomography.

Screw from the He vessel

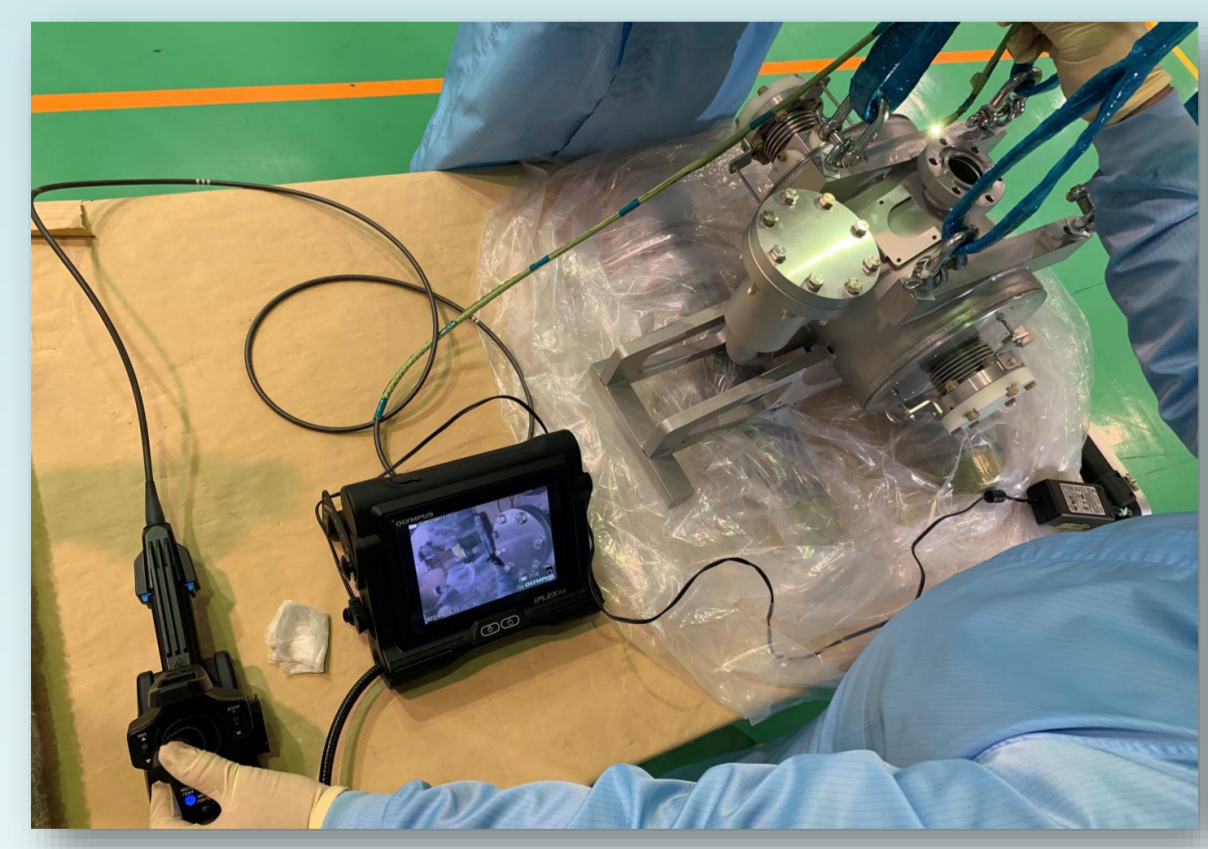
Endoscopy in the He vessel

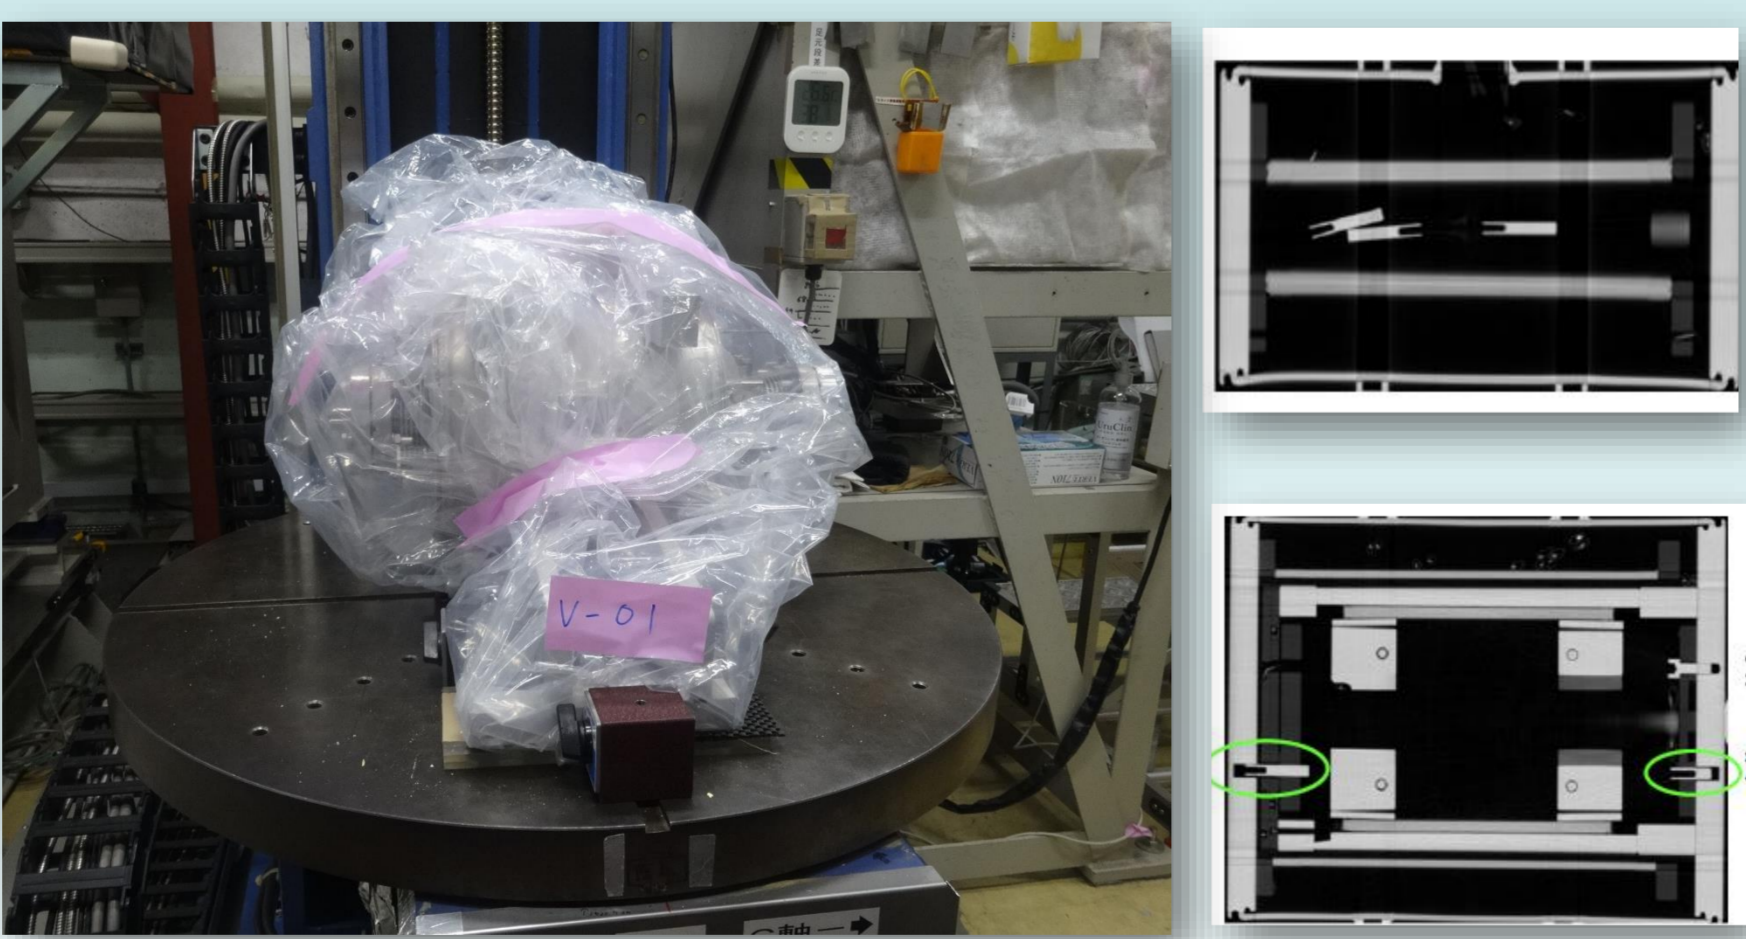
Solenoid tomography with retracted pins

- Tomography showed some solenoids had partially or fully retracted centring pins.
- Some pins were pushed out during the last assembly step of the solenoids.
- Two solenoids possibly critical for beam operation.
- Beam dynamic study done to position each solenoids at best on the beam line and operate in degraded mode if a failure occurs (*see Operational consideration in the LIPAc SRF with solenoid failure mode, T. Ebisawa, SRF2023*)

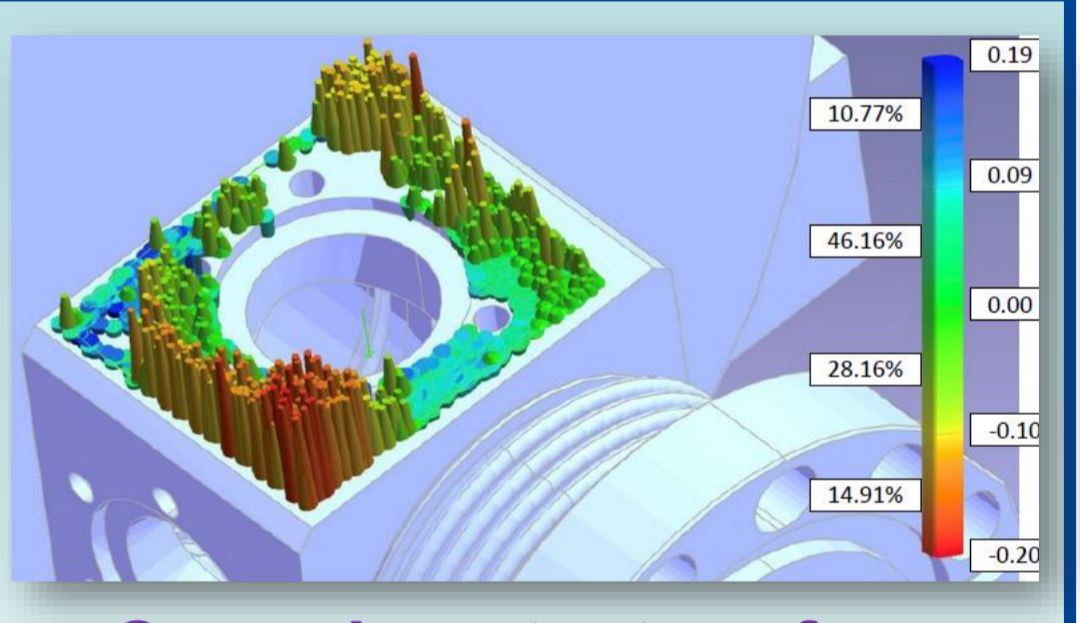
- One pick-up not fitting in V06 BPM.
- Suspected material stress released after reparation of one thread (welding).
- Pick-up diameter adjusted on a lathe machine.
- Assembly was possible but the pick-up leaked.
- Repolishing the sealing surface did not improve.
- 3D scan of the sealing interface reveal that sealing groove is flat but the depth is out of tolerance (tilted) => Uneven compression of the gasket

Curved contact surface

- ⇒ Now trying new gaskets:
  - Al diamond shape more resilient
  - Helicoflex with Tin coating
  - Helicoflex Delta shape

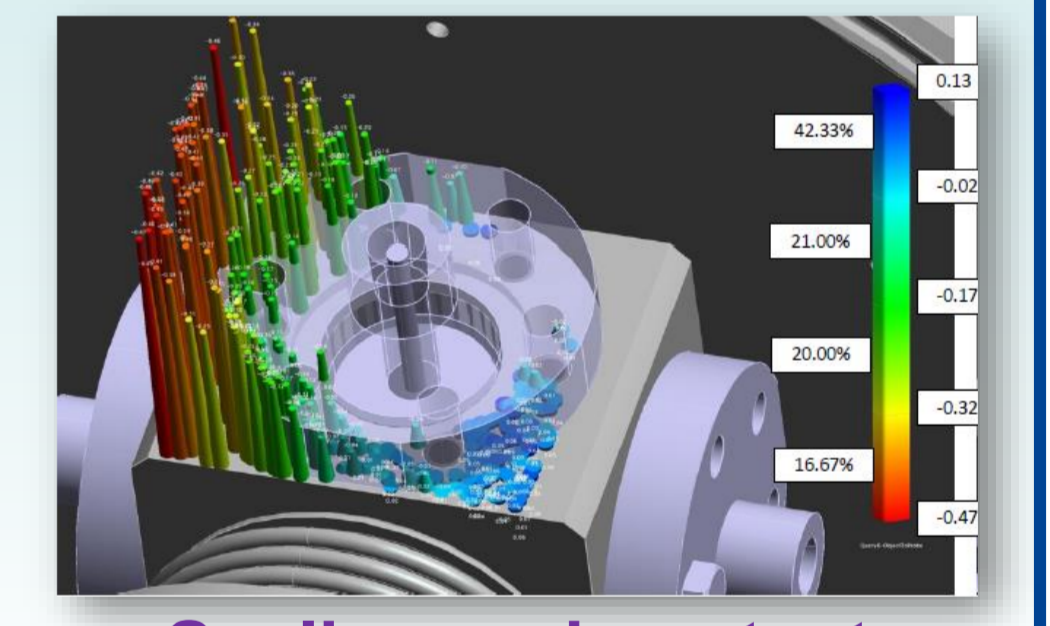
Sealing and contact surfaces parallelism

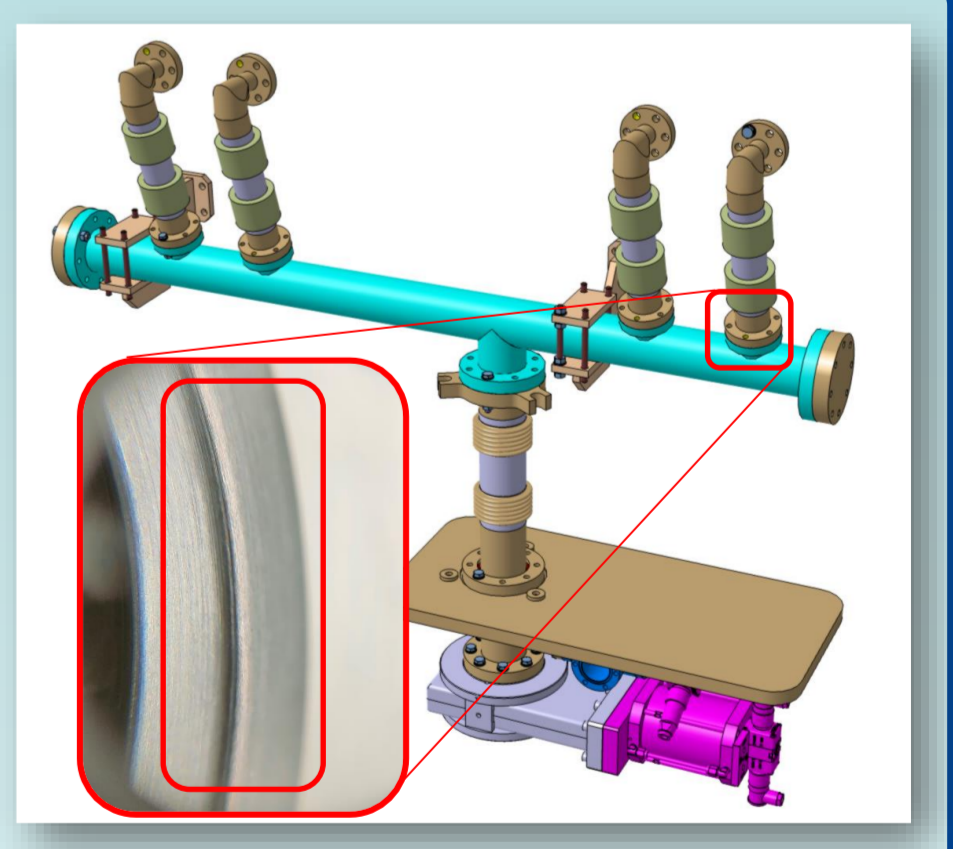
- The pumping manifold connected to the SRF cavities leaked (3 out of 7 flanges).
- The CF flanges suffered during pickling and passivation treatment.
- Edge knife protection leak during process resulting in rounding edges.
- Now procuring a new manifold.
- The two beam line transitions used a double gasket configuration for beam & insulation vacuum.
- The sealing surfaces missed the last polishing to get the proper Ra required by Helicoflex gaskets.
- Repolishing the surface did solve one leak but fastenings are very close to the bellow. A joint wrench had to be used implying less control on the torque value.
- ⇒ New tooling procured to better control the torque applied.
- ⇒ Additional gaskets with Tin plating being procured & Supplier of the gaskets involved in the analysis.
- ⇒ Alternative using an EPDM O-ring and Helicoflex combo being studied.

Rounded knife edge

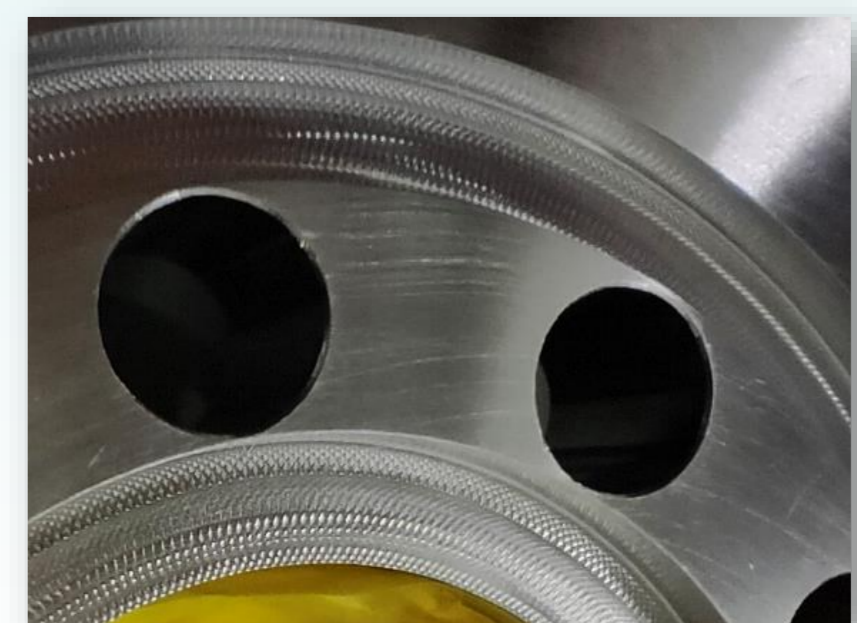
Sealing surface before and after repolishing
