## CLEANROOM ASSEMBLY OF THE LIPAc CRYOMODULE

### Abstract

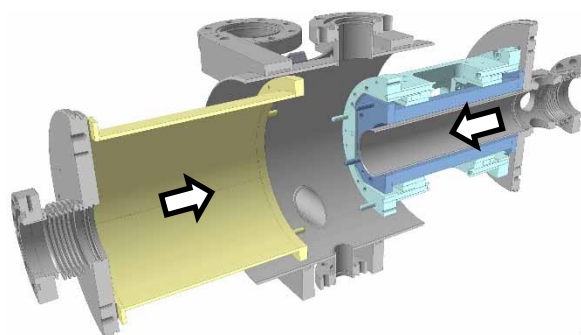
**Assembly principle of the solenoids** The solenoids where assembled following the principle shown in Figure 10. The inner coil and steerer magnets are positioned around the beam tube on one helium vessel wall. This sub assembly is positioned with centring pins and keep in position with screws. The opposite side of the sub-assembly is equipped with another set of centring that must fit the opposite wall. The external coil follows the same principle

Figure 10: Assembly principle of the solenoids. In blue the inner coil and steerer magnet. In yellow the outer coil.
