# Cleanroom assembly of the LIPAc cryomodule

## Superconducting Solenoids Reparation

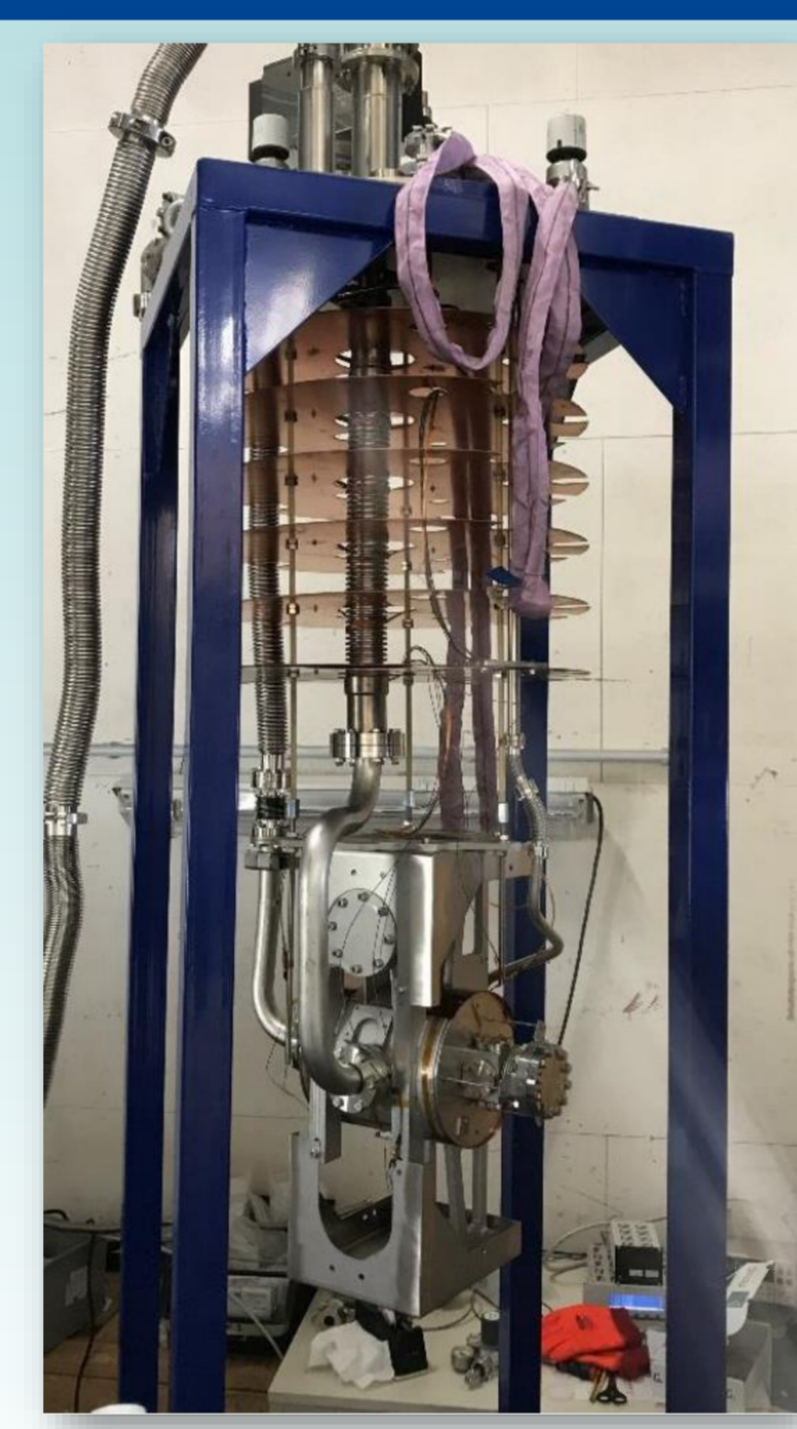
- Small test stand fed with Helium dewar.
- Leak detector suffer from helium contamination.
- Relocation of the leak detector to another room improved the test results.
- 2 solenoids presented leaks approaching the 70 k area => wrong configuration discovered on the current lead interface (O-ring instead of Helicoflex);

Solenoid on test insert

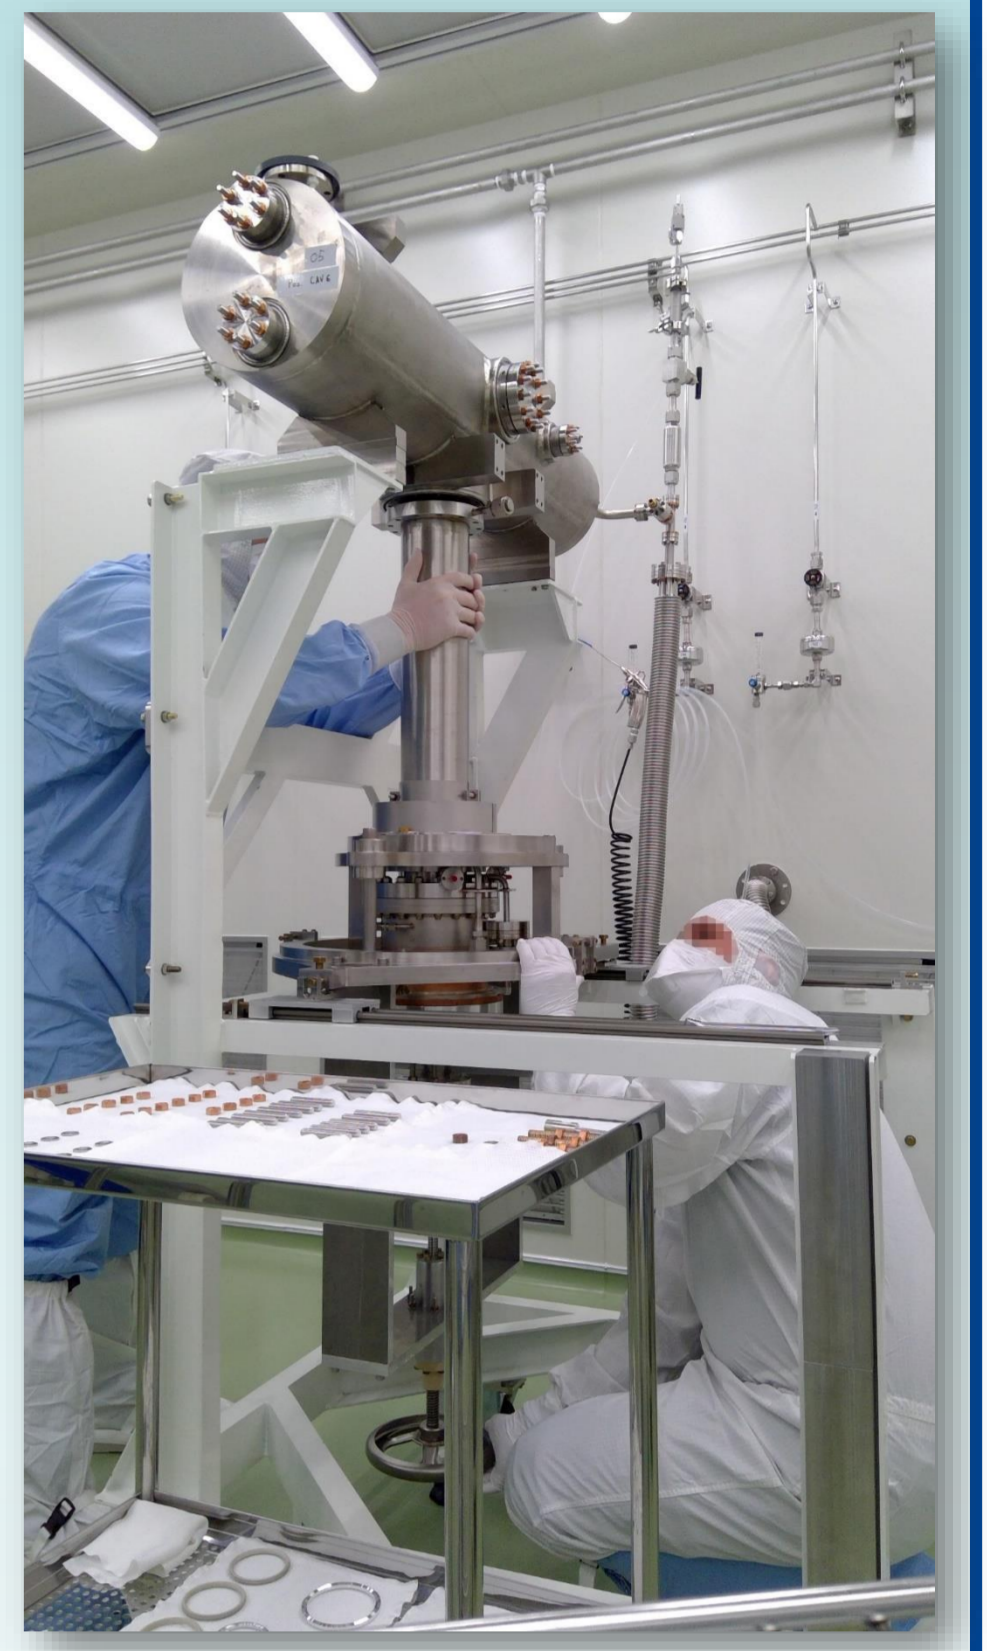
- 3 Cavity/Coupler already assembled in 2019.
- Cavities were closed with diamond shape gaskets on coupler port after RF vertical test. Final assembly is with Helicoflex gasket. Aluminium fillings found in some sealing grooves.
- Cavity/Coupler assembly went smoothly. 2 cavities needed 2 attempts to correct a small leak => Al filling from previous gasket suspected.
- Cavities were N<sub>2</sub> flush during assembly.
- 7 out of 8 solenoids were inspected and leak tested successfully.
- All cavities and a couple of solenoids sit now on the support frame and were pre-aligned for the string assembly.

Cavity/Coupler Assembly Courtesy of RI GmbH

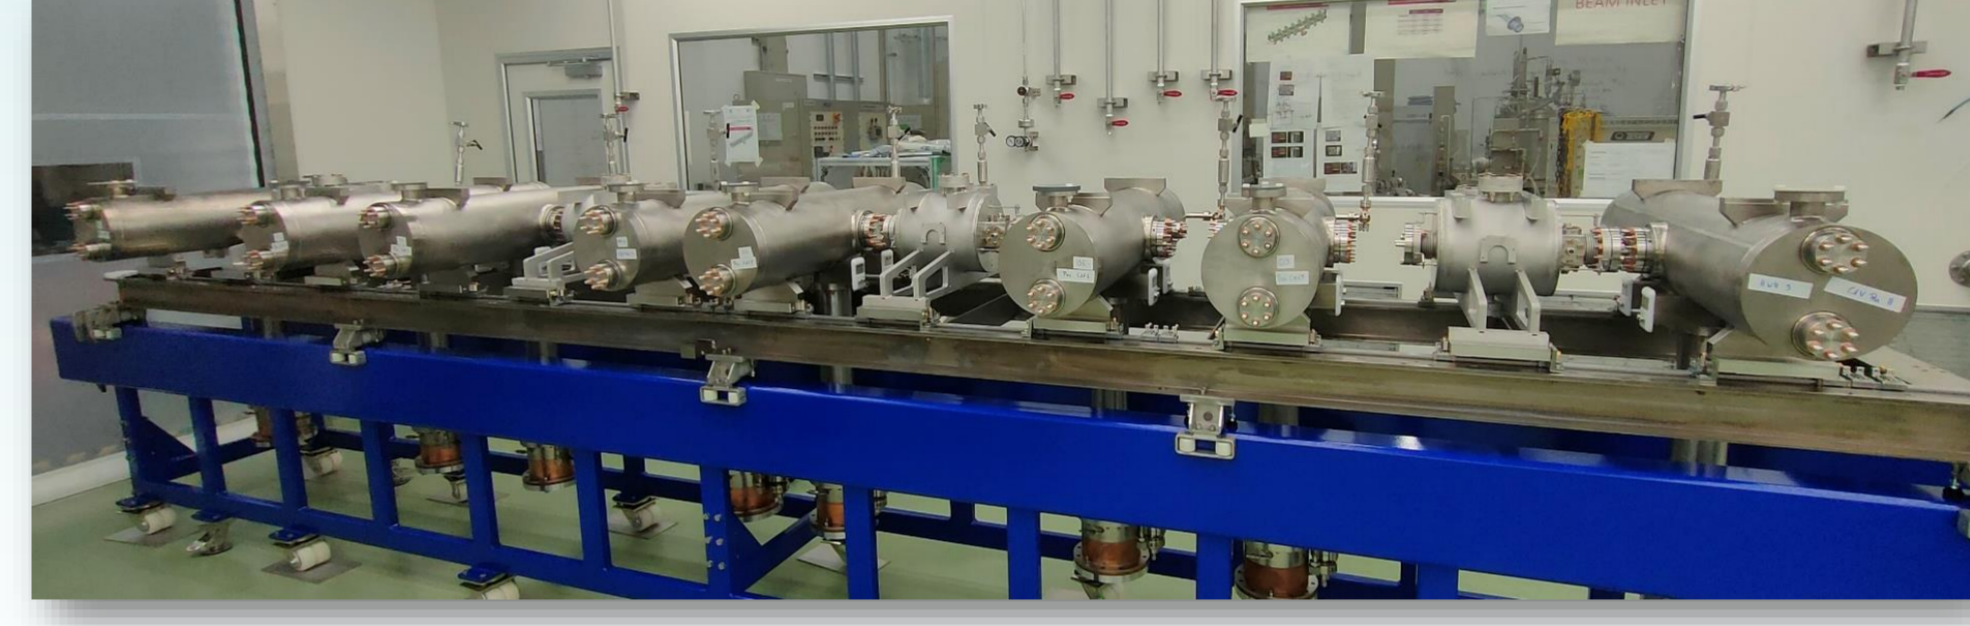
All 8 SRF cavities on the support frame

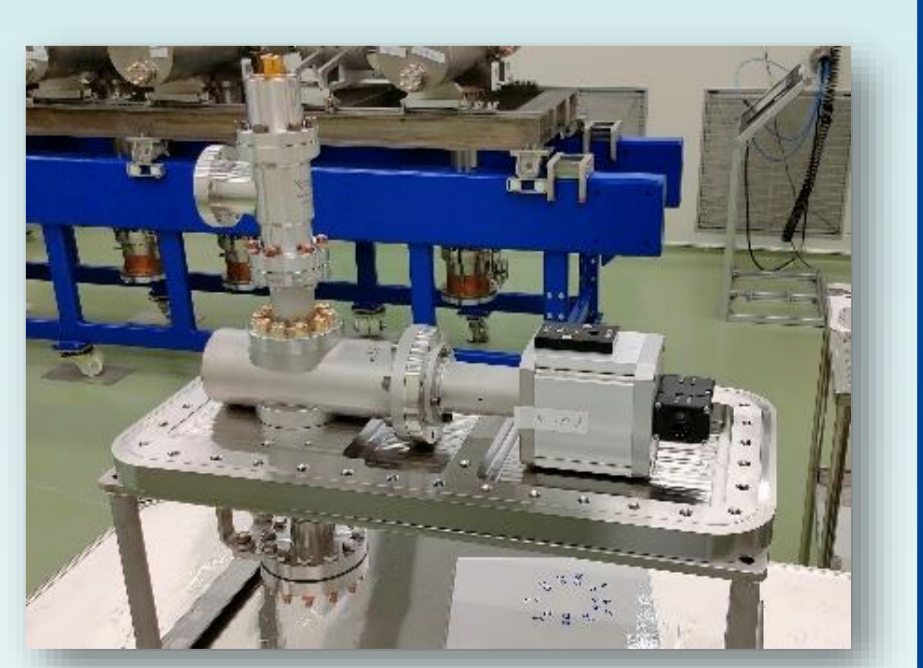
Beam transition assemble with gate valve
